New Zealand Conservators of Cultural Materials Pū Manaaki Kahurangi Annual Conference, 2018

AFTER QUAKE: ALEXANDER TURNBULL LIBRARY TWO YEARS

AFTER THE KAIKOURA EARTHQUAKE

RUTH OLIVER

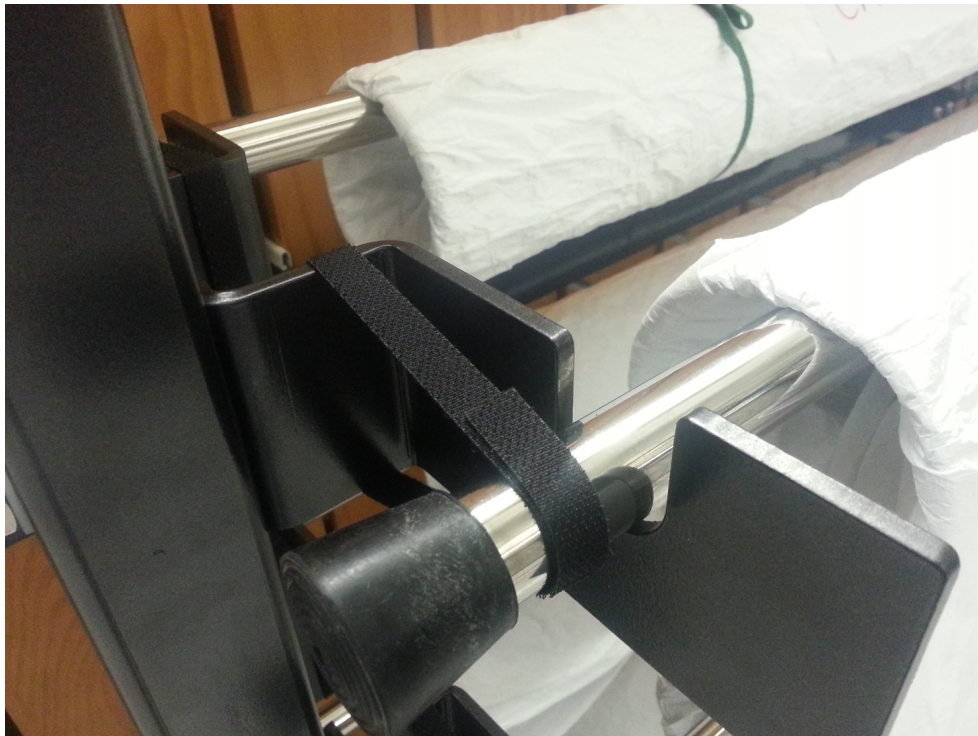
FIG. 2: The seismic restraint belt-and-brace system for rolled items was deceptively simple in appearance but it was strong, easy to install and ensured ease of access (courtesy Margaret Morris).

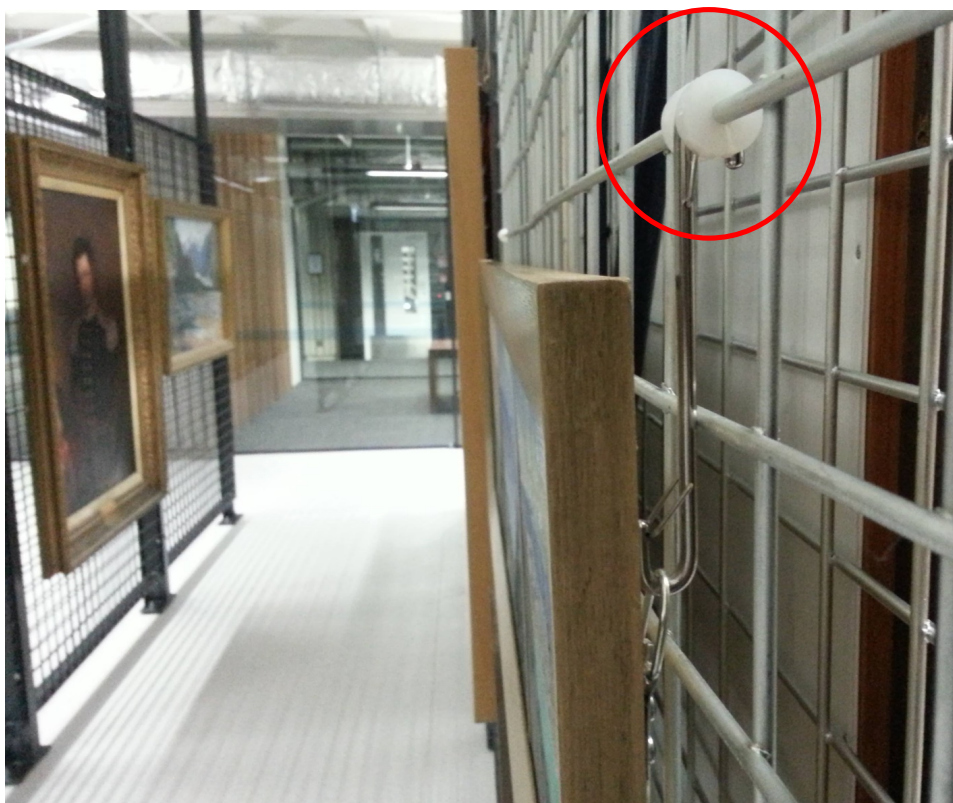
FIG. 3: The silicon bumper (circled) on each hanging hook significantly limits movement of the hook which protects the framed items from excessive movement during seismic activity (courtesy Margaret Morris).

The Library's Wellington building was shaken violently but there was very little damage caused to the collections. Within the Library, collection storage cabinets, installed during the refurbishment, had been braced to the floor and to each other. This bracing significantly inhibited the movement of the cabinets and while some of the drawers opened the units remained upright. A small amount of damage was done to a painting frame when the plastic cleat on one side failed. Following discussions the older system of plastic cleats and S-hooks was replaced by stainless steel brackets and D-rings (fig. 3).

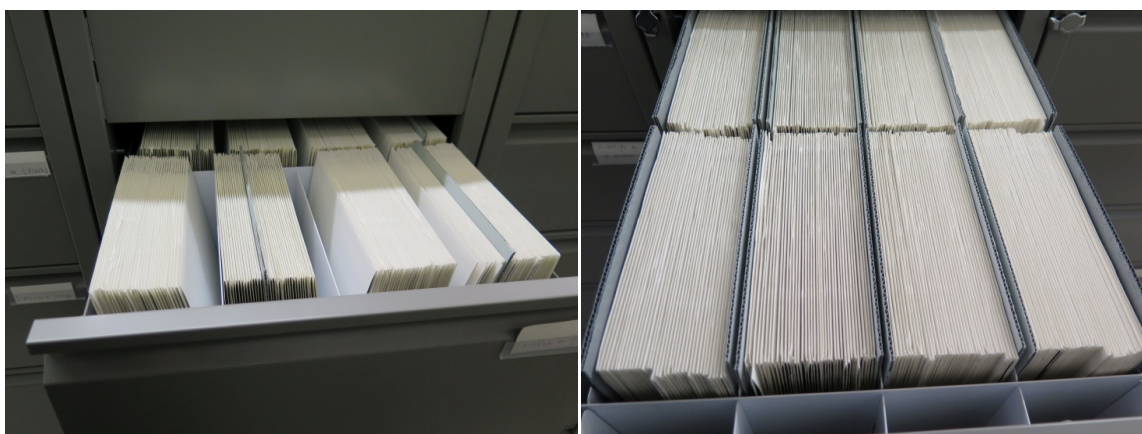
FIG 4 (left): Before closing gaps and packing out drawers containing glass plate negatives.

FIG 5 (right): After the completion of the project; rigid 'spacer' cards were also added when items were removed to close the gap and support adjacent glass plates.

Following the earthquakes, collection care staff identified storage furniture with low-earthquake resilience. Furniture above 1.2 metres in height was braced and fixed to the building. New cabinets were designed that incorporated seismic safety features and all new furniture was braced as soon as it was installed. 170,000 glass negatives were repacked in their drawers to close gaps and prevent movement within the drawers (fig. 4 & 5). Rigid 'spacer' cards were added to enhance cushioning and support; the spacers could be removed to allow easy access to the items.

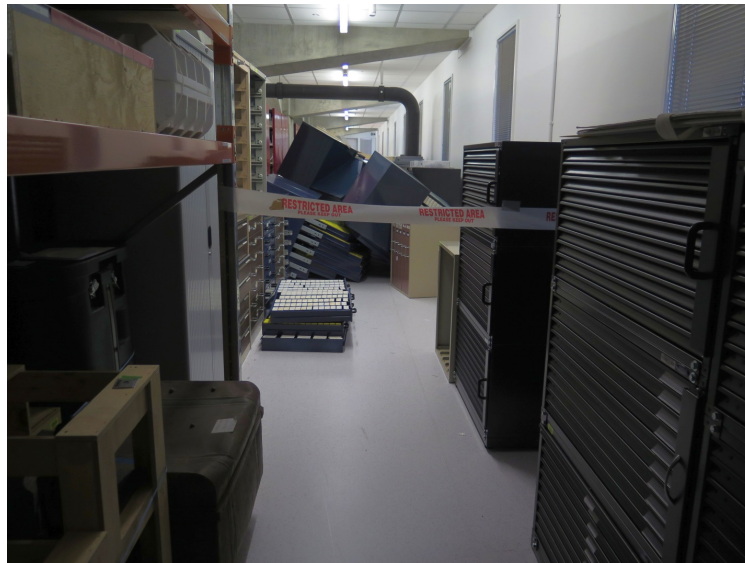
First response staff for the Library included DIA Property, the Library leadership team, the DDM and other senior collection care staff. An inspection tour was undertaken to establish if there were any immediate threats to the collections, such as burst water pipes. No imminent threats were found but it was clear that all the collections had moved during the earthquake. In some areas cordons were put in place, for example where the drawers on a row of cabinets had opened causing the cabinets to topple into the aisle. During the 2013 Seddon earthquake the bracing on these cabinets had performed well (no cabinets toppled), however the drawers on many of them opened. During the larger Kaikoura earthquake the weight of the drawers opening caused the bracing to fail and the cabinets toppled (fig. 6).

FIG. 6: Fallen two-part microfilm cabinets blocking the aisle and cordoned off (courtesy Margaret Morris).

Major projects to replace cabinets that didn't meet in-house standards were begun. The previously mentioned bank of cabinets that toppled were two-part, base-and-top units. They were replaced by a newly designed, integrated cabinet that was lower than the old two-part cabinets were. The new cabinets were attached to the floor and braced together in blocks of four. These small groups of braced cabinets avoided the creation of a braced 'wall' of 40 cabinets that could pull each other down through their combined weight during an earthquake.

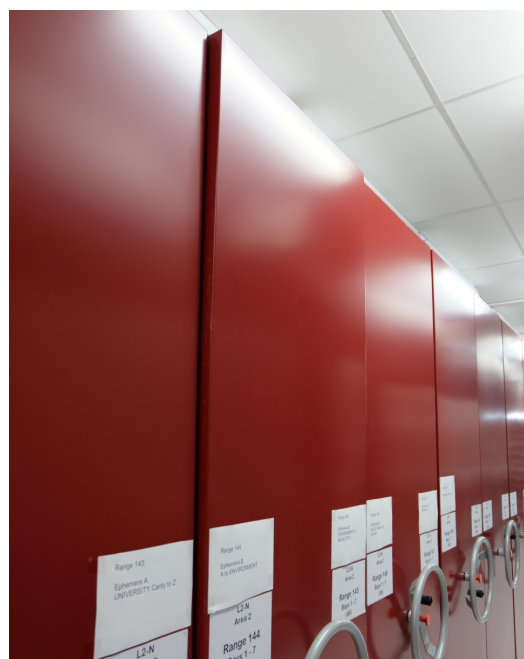
During early inspections of collection stores collection response staff and DIA Property noted that the shelving had moved enough to cause concern it was compromised and could be vulnerable to failure in future seismic events. Bracing on one range of shelving had partially

failed allowing it to move laterally and it was discovered that the shelving did not have cross bracing (fig. 7). It became imperative to find conclusive answers to what had happened to the shelving during the earthquake and why.

FIG. 7: The partially failed range in a level 2 store was out of alignment with adjacent ranges. The engineers recommended the installation of cross bracing to improve seismic resilience (courtesy Laura Mirebeau).

The engineer’s report also noted that the minor buckling of a shelving range on level 2 of the Library building was only one unit out of 800 similar units (Holmes Consulting 2017, 6).

Ultimately the engineers provided recommendations that would improve the earthquake resilience of the Library’s collection furniture. This information assisted the Library’s leadership and collection care in improving the safety of staff working within collection stores. It is important to understand, however, that engineers’ reports in general will not definitively state that a risk is acceptable. Engineers will simply state the risk and provide information on assessing and/or mitigating it. The final decisions and actions taken are the prerogative and responsibility of the group who commissioned the report.

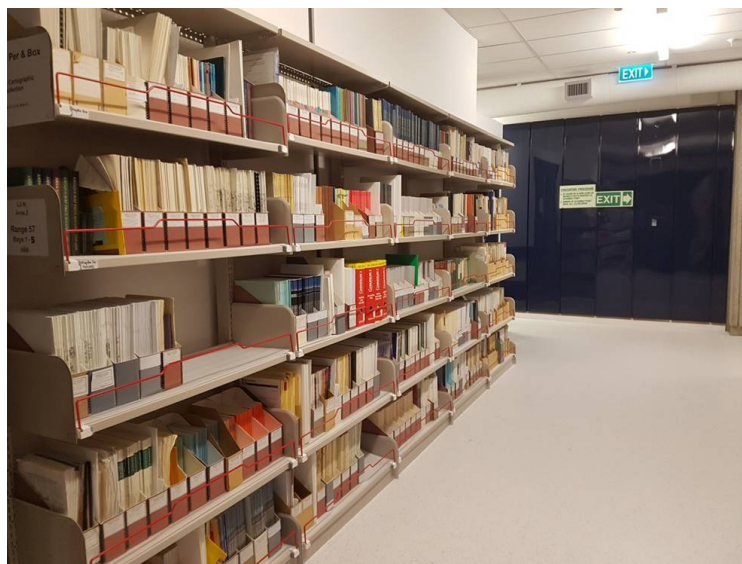
FIG. 9: Safety bars were installed on shelving along all collection store egress routes to protect staff from falling items and to ensure egress routes remained viable in a major earthquake (courtesy Alexander Turnbull Library).

The mobile ranges retain some hazards for staff therefore many procedural changes were implemented to keep staff safe while working in the collection stores. Plans were drawn up to identify areas of unacceptable risk and these areas were cordoned off and signage warned staff the areas were out of bounds. A ‘buddy system’ was initially enforced for all staff working in the collection stores. In/out boards were installed outside every store and staff were required to lock all ranges in the block where they were working or use the aisle blocks provided. Over time all egress routes within collection stores were upgraded so that shelving along these routes was fitted with safety bars to prevent the contents of the shelving falling during an earthquake (fig. 9).

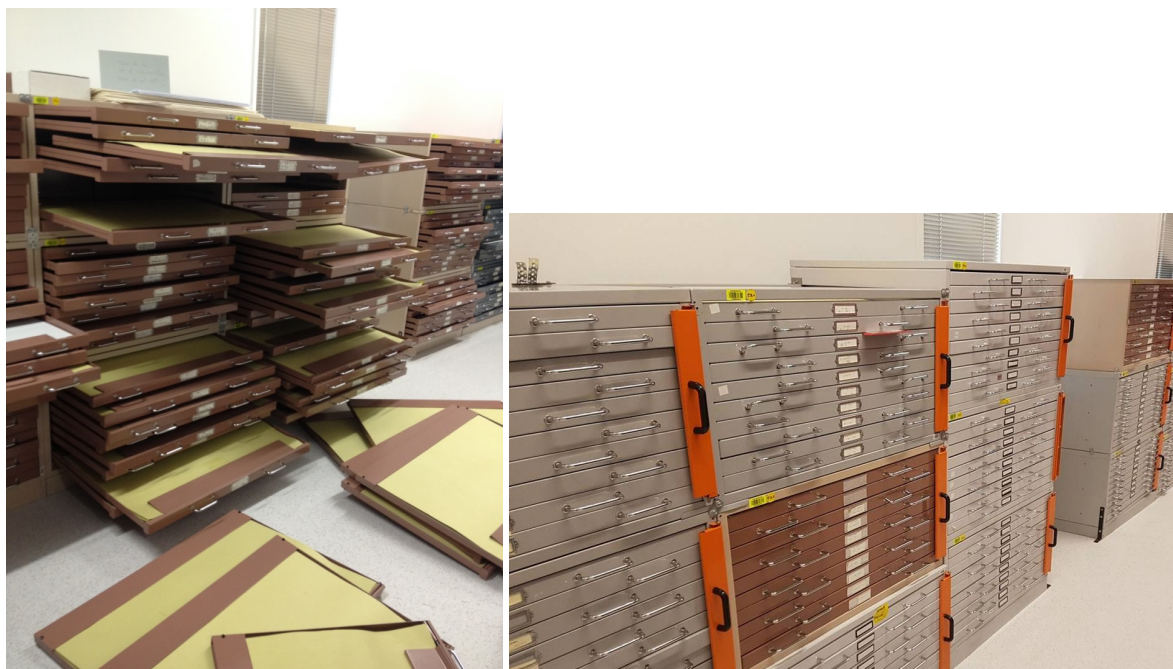
FIG. 10 (left): Cabinets on an upper floor after the Kaikoura earthquake in 2016 (courtesy Bronwyn Officer).

FIG. 11 (right): Retrofitted drawer guards prevent drawers opening in a seismic event. The guard is opened by lifting it up vertically and then swinging it to the side, out of the path of the drawer. Staff find the drawer guards quick and easy to use (courtesy Alexander Turnbull Library).

Further checks were done of existing cabinetry and remediation carried out. Existing furniture was modified, such as installing guards to prevent drawers opening in a seismic event (fig. 10 and 11).

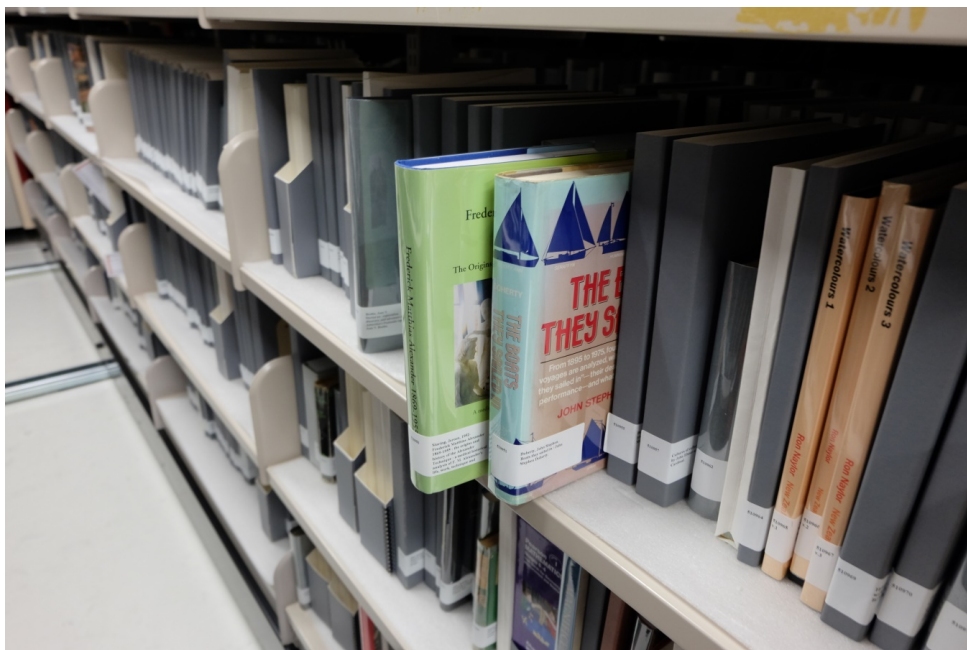
Books covered with protective plastic wraps had slid towards the edge of the shelves. The hard, smooth, polyester covers were slippery and caused the books to move more during the earthquake than books without these wraps (fig. 12). As a result newly acquired books are now covered in a light-card wrapper to mitigate this issue. The existing polyester wrappers remain as replacing these is a lesser priority compared to other seismic-protection measures.

FIG. 12: Two books with slippery polyester wrappers, protruding from the shelving after the earthquake (courtesy Laura Mirebeau).

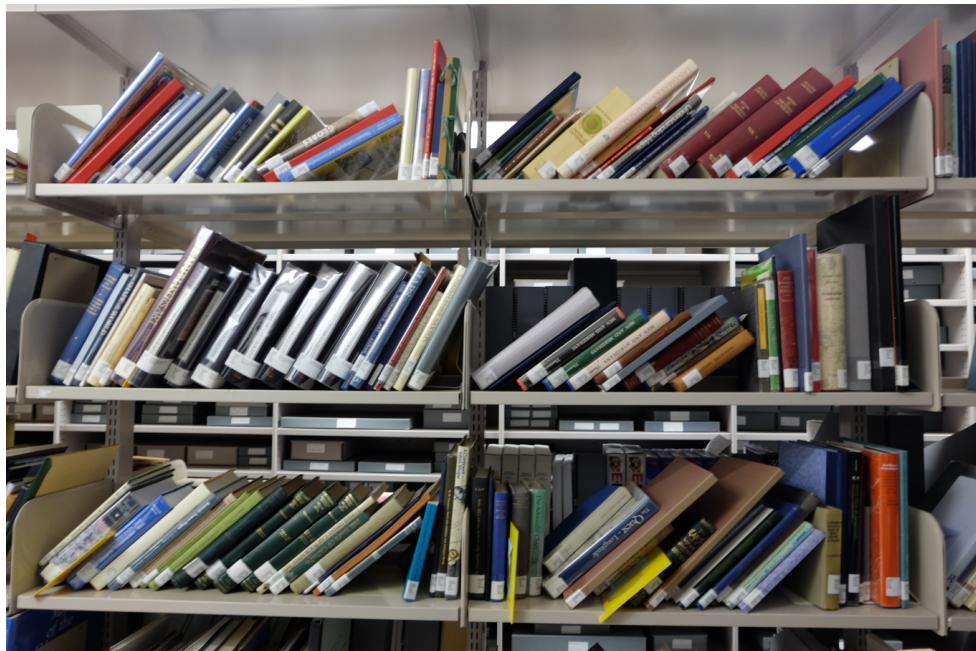
In the collection stores on level 2 the main issue involved books falling from shelving and, sometimes, falling between the ranges of shelving. A small ‘fist sized’ gap had been left on each shelf to allow for the extra space needed as items were boxed. Unfortunately these gaps increased the movement of books during the earthquake; if the shelves had been full the books would have supported each other inhibiting movement along the shelving. Another factor in the books falling was bookends that were not strong enough to withhold the weight of many books shifting sideways along the shelf. Many bookends bent which left whole shelves of books tilted to one side and caused some books to fall off the shelving (fig. 13).

FIG. 13: Partially full shelves where the books have moved along the shelf in the earthquake and have tilted (courtesy of Mark Strange).

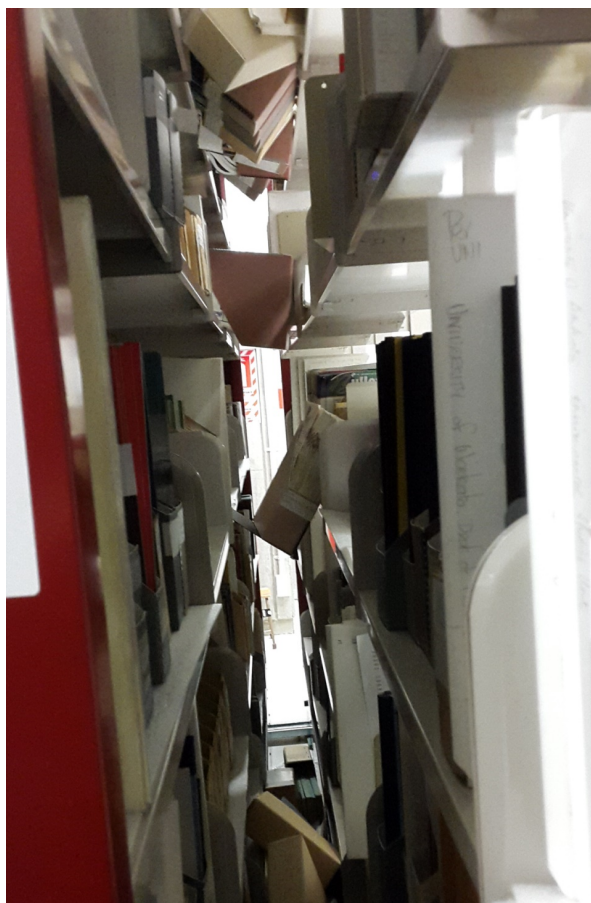
Prior to the earthquake some staff weren’t completely closing the gap between the shelving ranges, during the earthquake these gaps allowed some books to fall between the ranges (fig. 14). An unpackaged book falls freely and will often fall flat on its cover but a book constricted between ranges of shelving, will tend to fall directly downwards taking the impact on the head, tail or corners, causing damage to these areas. Packaged items that fell were undamaged because the packaging absorbed the impact.

FIG. 14: Items suspended between ranges and some that have fallen through the gaps onto the floor (courtesy of Alexander Turnbull Library).

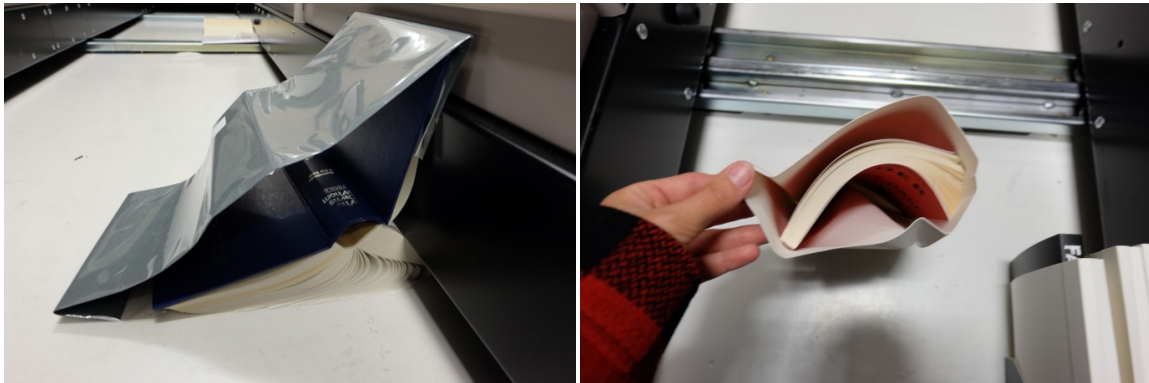
Some unpackaged books became stuck between ranges of shelves because the covers opened and became wedged but the text block was able to fall through the gap between the shelves (fig. 15). A few fragile books that were caught between shelving in this way had their covers torn off by the weight of the text block hanging through the shelving gap. Also, as it took some time for the recovery team to open and check between every range, the distortion caused to books that were stuck between ranges may not be easily reversed (fig. 16).

FIG. 15 & 16: Distortion caused to books that were able to fall from the shelving due to the gaps left between ranges when they were not completely closed together. Shelf restraints would also have prevented these items falling from the shelf (courtesy Nick Guy).

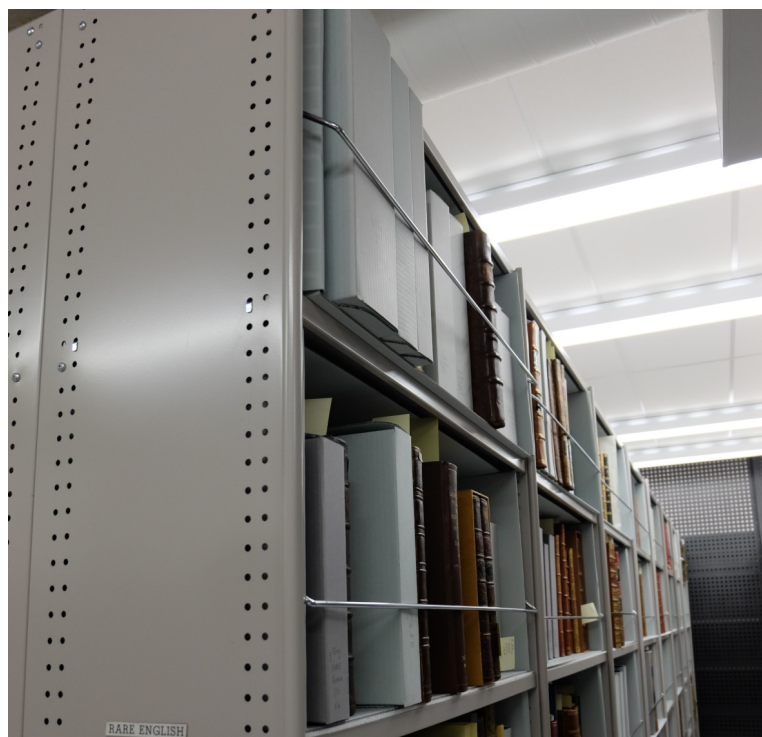
Some shelves in the collection stores had been fitted with seismic restraint bars to prevent items falling in an earthquake (fig. 17). On one shelf an older design of safety bar was sitting below a third of the way down the spine of the books, this allowed the books to topple over the bar and fall. This was considered an isolated case and has since been remedied. The vast

majority of the older earthquake bars and all the newer bar designs performed effectively and prevented shelf contents from falling.

FIG 17: Seismic restraints on shelving prevented the books that had shimmied forward on the shelf from falling onto the floor (courtesy Alexander Turnbull Library).

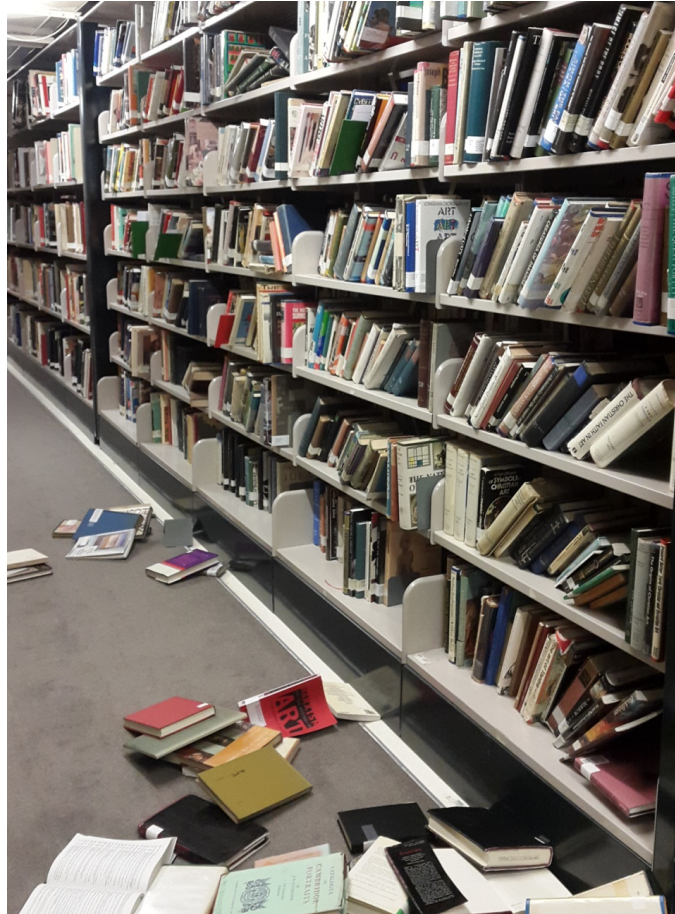
A partial answer could be found when observing two ranges of static shelving at basement level. These two ranges were nearly identical to each other; they were side by side, made by the same manufacturer, installed at the same time and contained very similar collections. The difference was that one range had anti-slip shelf liners while the adjacent range did not. The books on the range with liners remained upright and no books were dislodged from the shelf. The books on the range of shelves without liners were all tilted this way and that, and although most of these books remained on the shelves, some others fell to the floor (fig. 18).

FIG. 18: These shelves are part of a static range at the end of ranges of mobile shelves. The arrow indicates the transition between the bays with anti-slip shelf liners and the five bays (in the foreground) that have no shelf liners. The books on the background shelves stayed upright and none fell from the shelving (courtesy Alexander Turnbull Library).

The effectiveness of shelf liners cannot compete with fully packed shelves and earthquake restraints. The two latter measures especially out-perform liners during major seismic events and when collections are stored higher up in a building. The reality is that seismic restraints are expensive and they are one of the most effective ways to prevent collections falling from shelving during earthquakes.
