New Zealand Conservators of Cultural Materials Pū Manaaki Kahurangi Annual Conference, 2018

AFTER QUAKE: ALEXANDER TURNBULL LIBRARY TWO YEARS

AFTER THE KAIKOURA EARTHQUAKE

RUTH OLIVER

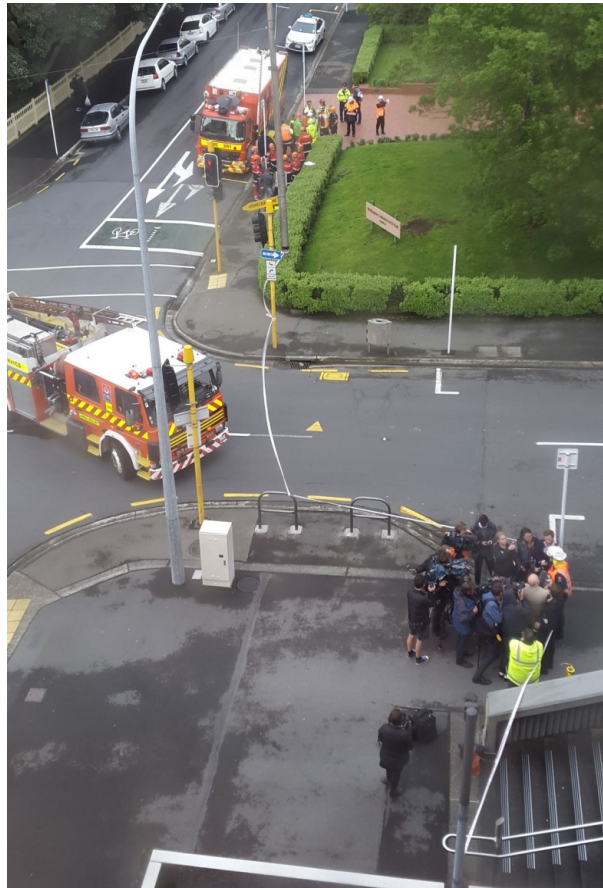
That same evening Molesworth Street was declared unsafe, access to the Library building was lost again and the 'second wave' of collection responders were stood down (fig. 8). The first responders worked hard to manage the new scenario. It was unlikely that 61 Molesworth Street would fall directly onto the Library building however a basement connected to the Library extends up Molesworth Street to number 61. The basement area directly under the Library building houses ATL collections and the much larger, adjacent basement houses NLNZ collections. The main fear was that the collapse of the building at number 61 would cause a 'dust bomb' that could breach the space between the two basements and affect the ATL heritage collections. The two basements were isolated from each other by sandbagging the fire doors linking them. All penetrations between the basements were closed and taped up to create a dust barrier. This work could only be carried out from the ATL basement as the adjacent basement was within the safety cordon for the unsafe building.

FIG. 8: View from National Library building (70 Molesworth Street), showing the southern end of the safety cordon on Molesworth Street due to the unsafe building at number 61 (courtesy Mark Strange).
